THE PUMP CURVE IS YOUR FRIEND

BY JIM ELSEY & The Summit Pump Team

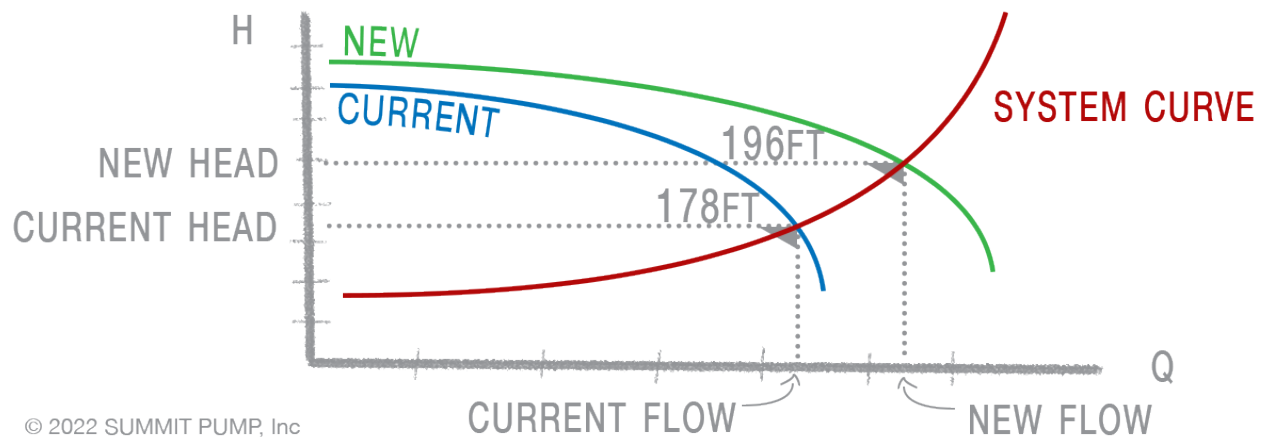
Dylan checked the current differential pressure across the pump as 77 psig (178 feet). The shop maintenance records documented the pump at 85 psig (196 feet) differential when it was first installed 3 years ago.

After converting the differential pressure to head, he looked over the pump curve for the hydraulic point where the pump would operate for the stated head based on the known diameter and speed. The head of 178 feet was further out and to the right on the operating curve than when the pump was new at 196 feet. The system's flowmeter indication did not correspond to the flowrate per the pump curve. The process was taking longer so a larger flowrate didn't make sense unless the pump was not operating on its published curve.

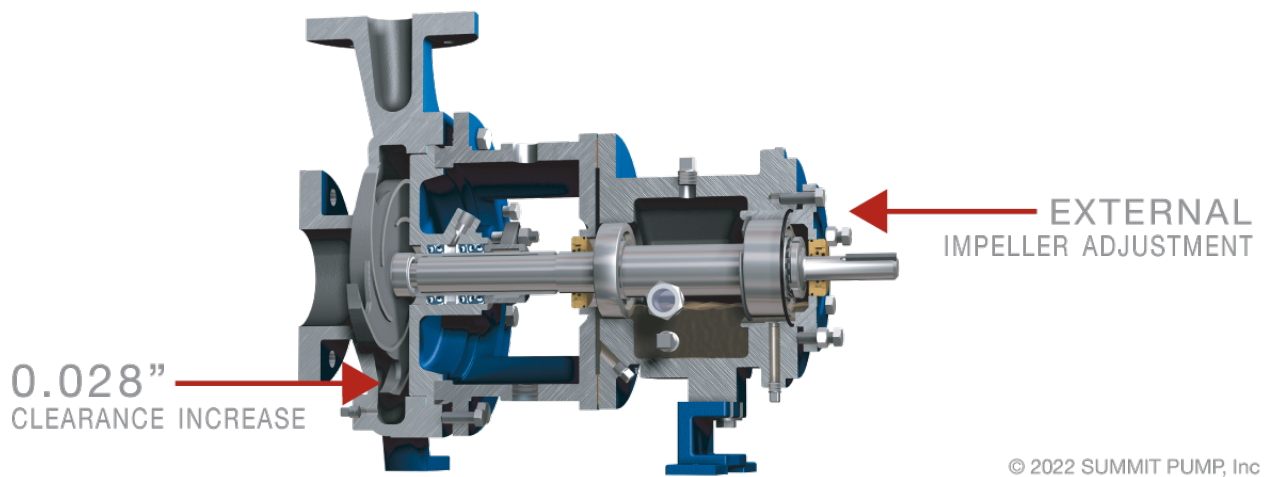
At the earliest opportunity Dylan scheduled the pump shut down and tagged out. Without disassembling the pump he was able to check the total axial travel of the rotating element and noted it was 0.028 inches more than when the pump was new. Dylan reset the impeller clearance in accordance with the IOM (Instruction and Operating Manual) specifications for the size/model and product temperature.

As the pump operated over the last few years the clearance between the impeller and the casing had worn by 0.028 inches. The wear occurred slowly over a long period of time and so the operators didn't notice until the change was significant.

The wear (clearance) was enough to make the pump perform as if it was operating at a lower speed or the impeller had been trimmed. The pump was not operating on its original published curve due to the wear, however still intersected the system curve at a lower head.

The pump was returned to service and the pressure differential returned to 85 psig. The process time for unit C returned to normal with the improved flowrate.
