# WHAT'S CAUSING YOUR **LEAKY** BEARING ISOLATOR?

BY JIM ELSEY & The Summit Pump Team

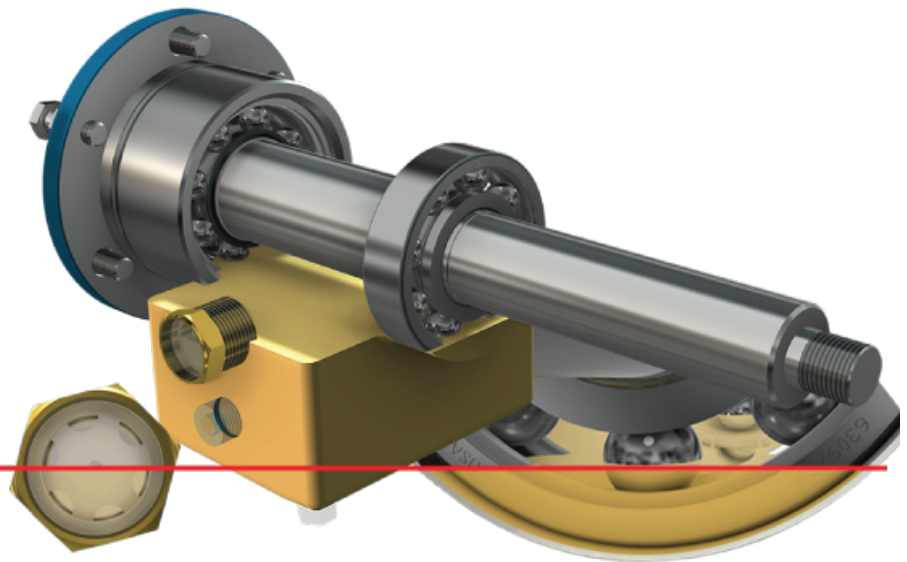
# MAXIMUM OIL LEVEL

- **1.) Overfill of the bearing housing** is the most common reason for oil leakage. The oil level should be at and *no higher* than the middle of the sight glass. This "sighted" level should correspond with the middle of the lowest ball in the ball bearing set, either radial or thrust.

**Field Tip:** It is important to understand that once the housing is overfilled it will take some time for the excess oil to be dissipated from the saturated isolator. In the interim it is important to continue cleanup of the expelled oil for several days or even weeks of running post overfill incident.

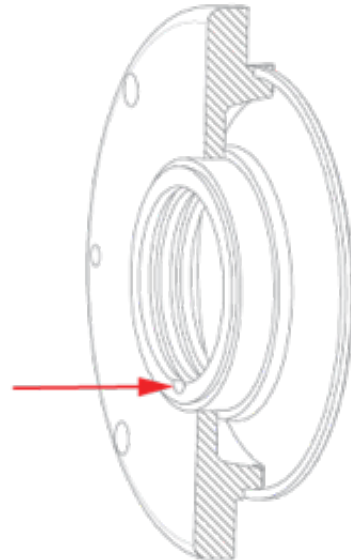
**EXPULSION PORT**  
6 O'CLOCK POSITION

- **6.) Expulsion port is in the wrong location.** It must be at the 6 o'clock position.

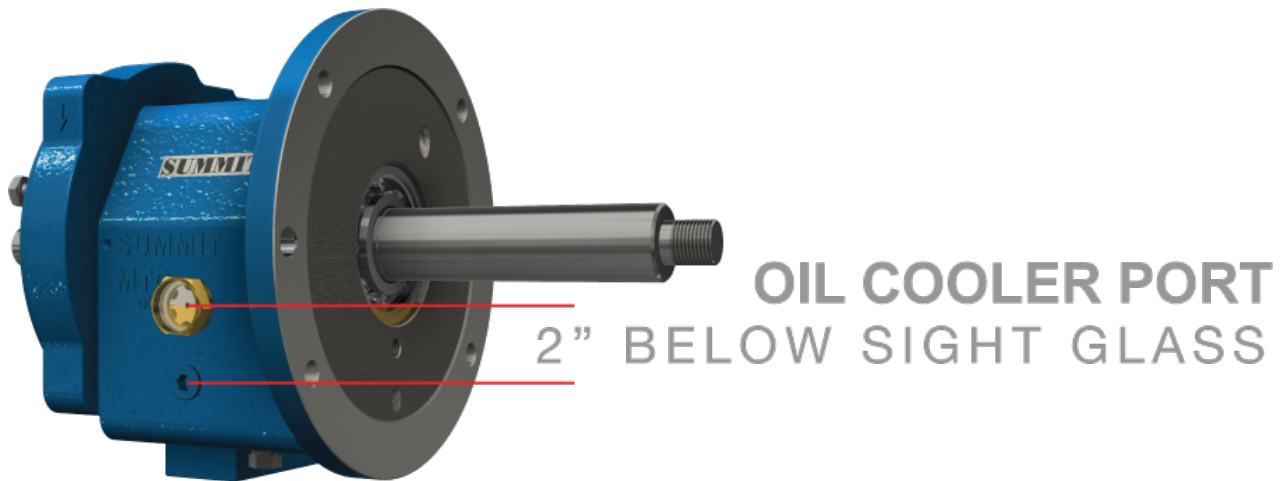
- **17.) Oil sight glass is located at the incorrect height** (manufacturing or repair defect). While not a leak issue, but of interest on this subject. We have witnessed the end user installing the (ANSI) pump next to a wall with the oil sight gage glass (indicator) on the wall side of the pump. To achieve direct line of sight to the indicator, the operator removed the sight gage from the port side of the pump and relocated it on the other side (starboard) of the bearing housing.

On most ANSI pumps there is a normally plugged penetration where the finned oil cooler would be located, if used. Both the oil cooler and the sight glass penetrations are sized at 1" NPT. However, the centerline of the cooler penetration is at a slightly lower level (in this case 2") than the sight glass penetration to allow for shaft clearance. The result is that the new corresponding oil level will now be too low and consequently incorrect. The resulting bearing life will be severely compromised due to inadequate lubrication.

*Note that some pump manufacturers have penetrations on both sides of the pump bearing housing for the sight glass installation on either or both sides.*
